Real-Time Fluoroscopic and C-Arm Computed Tomography Evaluation of Ommaya Reservoir Integrity

Adrienne M. Moraff¹, Melanie Hayden Gephart¹, Larry M. Shuer², Jeremy J. Heit³

Abstract

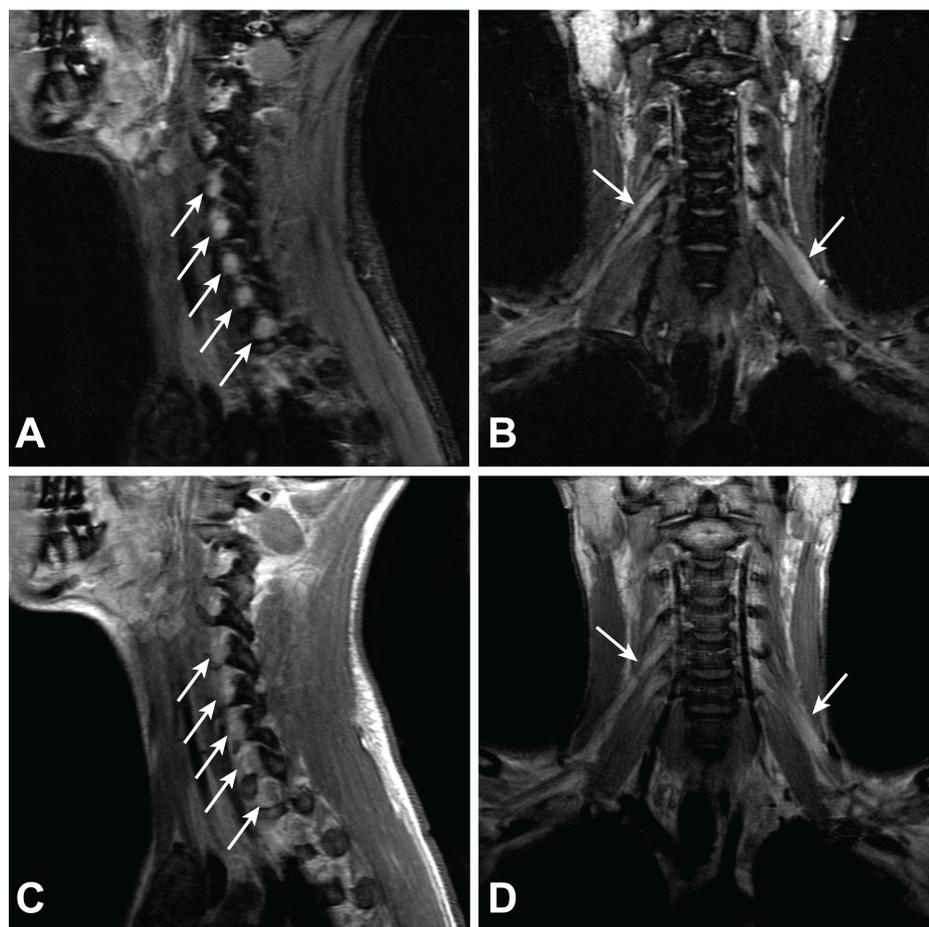
FIGURE 1: Brachial plexus magnetic resonance imaging demonstrating leukemic infiltration of the bilateral nerve roots.

(A, B) Short tau inversion recovery (STIR) images demonstrate nerve root thickening and increased T2-weighted signal abnormality (arrows) in the sagittal (A) and coronal plane (B). (C, D) Post contrast images show diffuse enhancement within thickened nerve roots of the brachial plexus in the sagittal (C) and coronal plane (D).

The patient initially did well after his bone marrow transplant, but nine months later he developed neck spasms and right upper extremity neuropathy. He underwent an MRI scan of the right brachial plexus (Figure 1), which demonstrated nerve root thickening that was found to represent leukemic infiltration. A lumbar puncture demonstrated evidence of blasts in the CSF. There was no evidence of peripheral disease recurrence upon repeat bone marrow biopsy and a complete imaging evaluation. The patient underwent treatment with high-dose cytarabine and dexamethasone. A right frontal Ommaya reservoir was placed using stereotactic guidance for weekly intrathecal chemotherapy.

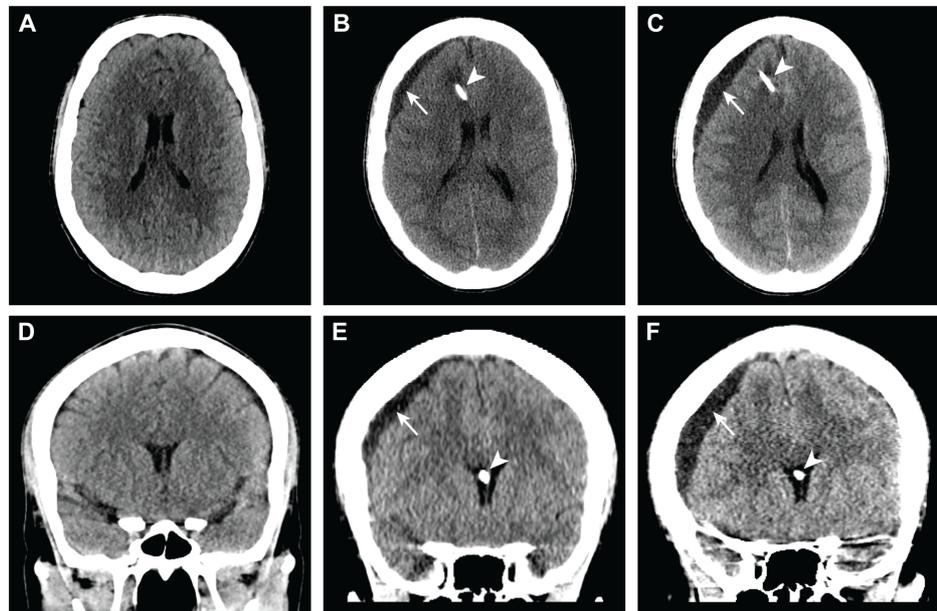
FIGURE 2: Head computed tomography images before and after Ommaya reservoir placement demonstrate increasing size of a right subdural collection.

Axial (A-C) and coronal reformations (D-F) from a non-contrast head computed tomogram demonstrate a normal appearance of the brain prior to Ommaya reservoir placement (A, D). After Ommaya reservoir placement, the catheter (B, C, E, F, arrowheads) traverses the right frontal lobe (B, C) and terminates in the right lateral ventricle near the foramen of Monro (E, F). There is a hypodense subdural collection (B, C, E, F, arrows) overlying the right frontal lobe that was initially small (B, E) but increased on a follow-up study (C, F).

The patient developed a headache seven days after placement of the Ommaya reservoir, and there was difficulty in accessing the Ommaya. A head CT demonstrated appropriate positioning of the Ommaya reservoir tip in the frontal horn of the right lateral ventricle, but a new hypodense 5-mm extra-axial collection overlying the right frontal lobe was present (Figure 2). The patient's headache worsened, and he developed nausea and vomiting with intrathecal chemotherapy administration. A follow-up head CT demonstrated an interval increase in the size of the right frontal extra-axial collection with an associated increase in local mass effect on the adjacent cerebral sulci and modest midline shift.

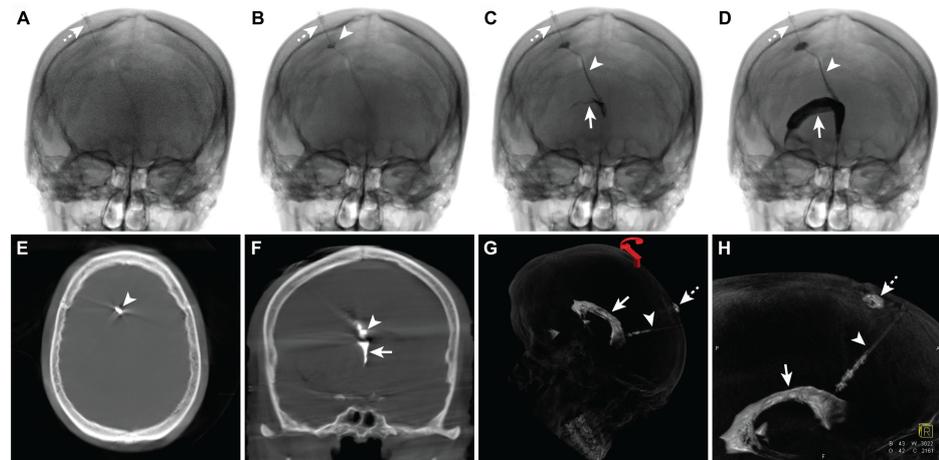
FIGURE 3: Fluoroscopic images during contrast injection of the Ommaya reservoir and flat panel computed tomography images after contrast injection.

Serial fluoroscopic images (A-D) obtained during iodinated contrast injection of the Ommaya reservoir demonstrate the needle in position within the reservoir (A-D, dashed arrow) prior to injection (A) and during injection (B-D). There is progressive contrast opacification of the Ommaya reservoir (B, arrowhead), tubing (B, C, arrowhead), and right lateral ventricle (D, arrow), but no contrast extends into the subdural space. (E-H) Three-dimensional images reformatted from a flat panel computed tomography study after Ommaya reservoir contrast injection. There is no contrast evidence within the right frontal subdural collection (E, F). The Ommaya tubing is well seen with contrast within it (E, F, arrowhead), and contrast is noted filling the third ventricle on the coronal image (F, arrow). Additional reformatted images (G, H) demonstrate contrast filling the Ommaya reservoir (G, H, dashed arrow), tubing (G, H, arrowhead), and right lateral ventricle (G, H, arrow). No contrast extends outside of the Ommaya reservoir or ventricle system into the subdural space.

To assess the integrity of the Ommaya system and leakage into the subdural space, the patient was brought to the neuroendovascular suite for real time fluoroscopic evaluation of the Ommaya following contrast injection of the reservoir. The neuroendovascular suite is equipped with a Siemens Artis Zee biplane fluoroscopy unit with flat panel CT capability. The patient was placed supine on the angiography table. The skin overlying the Ommaya reservoir was sterilely prepared and draped in a standard fashion, and the reservoir was accessed with a 22-gauge butterfly needle. Return of clear CSF was verified after this access, and 5 ml of Omnipaque 300 contrast dye was slowly injected into the Ommaya reservoir. The contrast injection was monitored with continuous low-dose single-plane fluoroscopy (Figure 3A-D). The injected contrast remained confined to the Ommaya reservoir and catheter, and there was an appropriate filling of the right lateral and third ventricles. There was no contrast leakage into the subcutaneous tissues, subdural space, or brain parenchyma. Similarly, no blockage or delayed flow of contrast was observed to suggest blockage within the Ommaya system. A flat panel CT was then performed, and three-dimensional

reformations were made on a separate workstation (Figure 3E-H). These images again demonstrated no evidence of contrast leakage into the subdural space or other location outside the Ommaya reservoir or normal CSF space. The butterfly needle was removed. The patient tolerated the procedure well, and there were no complications related to the procedure.

The patient was transferred to the operating room, where a right frontal burr hole craniotomy posterior and separate from the Ommaya incision was performed. A hemosiderin-stained clear subdural collection was evacuated without difficulty, and the underlying brain expanded intra-operatively after this evacuation. The patient recovered uneventfully from the surgery, and his headache, nausea, and vomiting resolved. He was discharged home seven days after the evacuation of the subdural collection.
