Myelopathy Improvement Following Removal of Cervical Sublaminar Wiring

Keywords: cervical spine, sublaminar wire, wire complication, cervical myelopathy

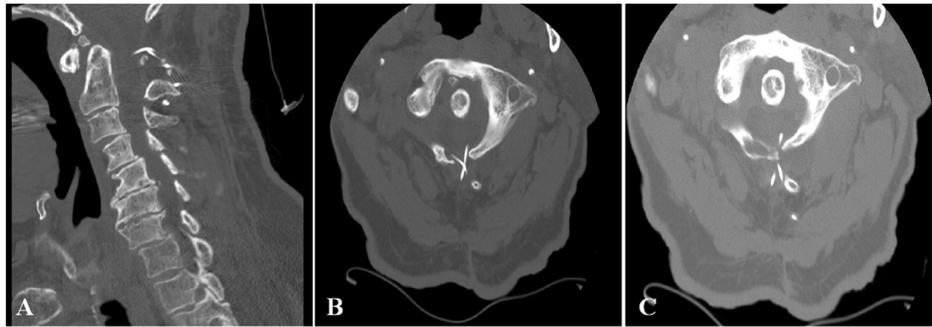
FIGURE 1: Preoperative Cervical CT Scan

Cervical computed tomographic (CT) scan without contrast demonstrating sublaminar wiring in (A) sagittal and (B, C) axial views. On inspection, it appears as if the upper cervical wiring has encroached into the spinal canal with concern for dural and cord penetration.

At his initial presentation, the patient was found to have pseudoarthrosis at the initial cervical repair site, spasticity of the left lower extremity, and diffuse weakness of the left upper extremity to the point that he was only able to overcome gravity (i.e. graded 3/5). The patient was also found to exhibit pronator drift of the left upper extremity on examination. The patient's right upper and lower extremities were neurologically intact. Reflexes were 2+ throughout, and his sensorium was normal on exam. A cervical computed tomography (CT) scan without contrast demonstrated sublaminar wiring between C1 and C2 with the encroachment of the upper cervical wire into the spinal canal with concern for dural and cord penetration as shown in Figure 1. A magnetic resonance imaging (MRI) scan of his cervical spine confirmed dural and cord penetration by the wire associated with an eccentric left-sided syrinx at C2 as shown in Figure 2. A pseudomeningocele can also be seen.

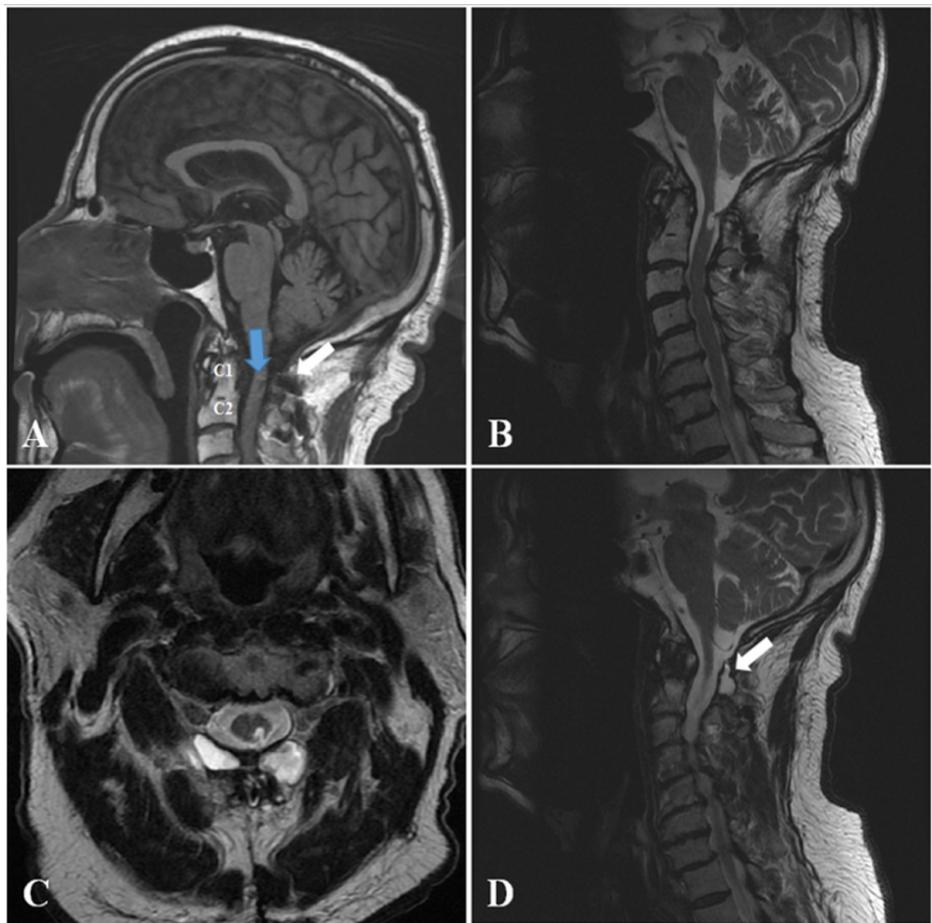
FIGURE 2: Preoperative Cervical MRI Scan

Preoperative magnetic resonance imaging (MRI) scan demonstrating T1 and T2 changes in the cervical spinal canal. (A) T1-weighted non-contrast image of the cervical spinal cord demonstrating a pseudomeningocele (white arrow) and intensity change in the cord between levels C1 and C2 (blue arrow). T2-weighted non-contrast imaging also demonstrates the syrinx accompanying wire encroachment in (B) sagittal and (C) axial views. (D) T2-weighted non-contrast imaging re-demonstrating the pseudomeningocele (arrow) in this patient.

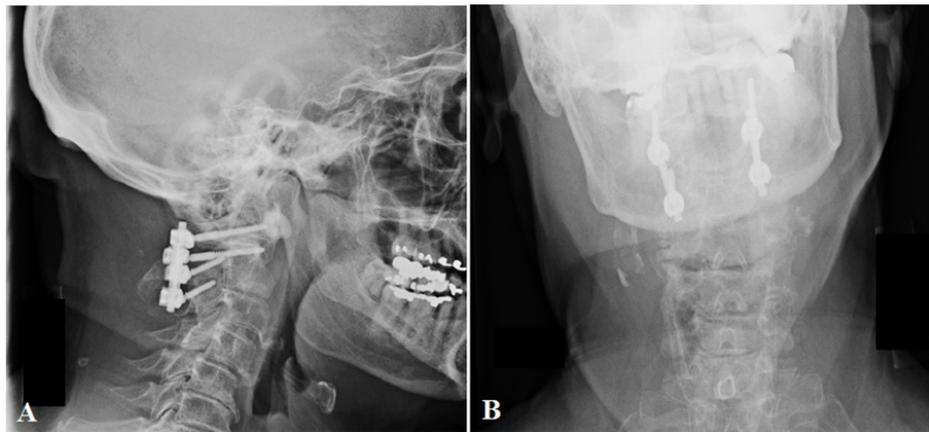
FIGURE 3: Postoperative X-ray Scans

Postoperative X-rays (A, B) demonstrating removal of the sublaminar wires and proper hardware placement with fusion of cervical levels C1 and C2. Fusion was achieved using C1 lateral mass screws, C2 pars interarticularis screws, and rods.

The patient underwent operative removal of the broken sublaminar wires, repair of the durotomy, and posterior fusion with C1 lateral mass screws, C2 pars interarticularis screws, and rods. Image guidance was used for screw placement. Intraoperatively, spinal fluid was noted to be coming from areas not immediately adjacent to the dura. Dissection was continued until all potential sources of leakage were repaired and all

wiring from the previous operation was accounted for and removed. Intraoperative and postoperative imaging showed proper hardware placement (Figure 3).
