Re-expansion of Osteoporotic Compression Fractures Using Bilateral SpineJack Implants: Early Clinical Experience and Biomechanical Considerations

Jacobson R E, Nenov A, Duong H D (April 30, 2019) Re-expansion of Osteoporotic Compression Fractures Using Bilateral SpineJack Implants: Early Clinical Experience and Biomechanical Considerations. Cureus 11(4): e4572. DOI 10.7759/cureus.4572

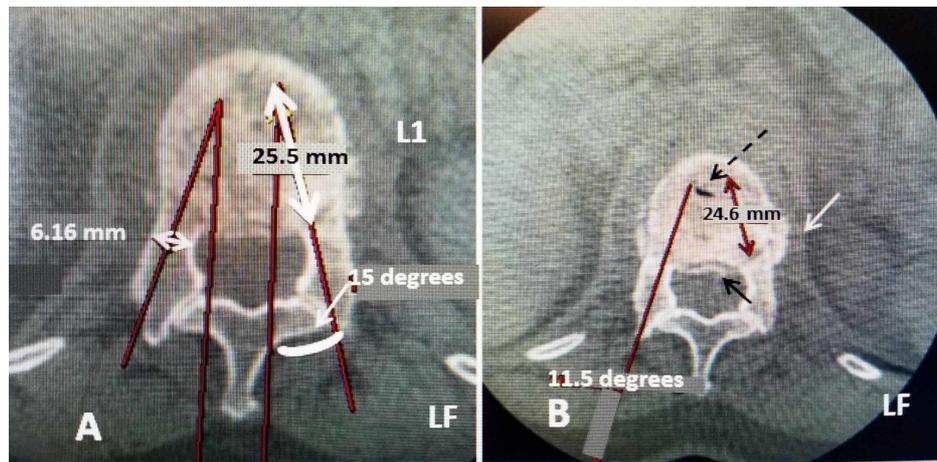
FIGURE 1: Measuring the fractured vertebral body to determine pedicle diameter and length to size correct implant to be inserted

A: Axial CT scan of L1 fracture. The red line through the pedicle shows the angle (15 degrees) and position for placement of the implant. The 25.5-mm measurement is the maximum length of the implant (double-headed white arrow) on left (LF). The pedicle diameter 6.16 mm is also marked (small double-headed arrow on right over pedicle) to get the width of the closed implant that can be inserted. The final implant size is determined by both pedicle diameter (between the side cortex) and length to properly center the implants under the fractured endplates. In this case, a 5.8 x 20-mm implant can be used.

B: Axial slice showing the angle (11.5 degrees) of insertion of the implant (solid red line). The fracture starts from the base of the L1 pedicle on the left side (LF) (solid white arrow). Minimal posterior displacement of the fracture into the spinal canal is seen (small solid black arrow). The length of the fractured endplate of 24.6 mm is measured (double-headed red arrow) which determines the maximum size implant that can be centered under the fracture. The slight lateral displacement of the fracture on the left can be seen (solid white arrow). A vertebral cleft is also identified in L1 in the anterior part of the fracture (dashed black arrow). The two SpineJack implants will be positioned anteriorly on each side of the cleft and cement will fill the cleft defect between the two implants.

The first step in using the implants is the measurement of the fractured vertebra for proper sizing and to make sure there is not extensive comminution of the pedicle or posterior vertebral wall [4,6-7]. Either computerized tomography (CT) or magnetic resonance imaging (MRI) films in sagittal, axial and coronal views are made to assess the integrity of the posterior vertebral wall, the pedicle and the depth of the anterior vertebra from the pedicle base and the diameter of the pedicle [10]. Precise measurements of the inner cortical pedicle size and the depth of the vertebra in a line projected from the anterior-medial to more posterior-lateral part of the vertebra will aid in planning where the implant will be positioned in line with the pedicle. This, in turn, allows exact sizing of the originally closed SJ so it can fit through the pedicle and is positioned properly to provide support along the maximum length of the fractured endplate and also centered underneath the fractured endplate (Figure 1).

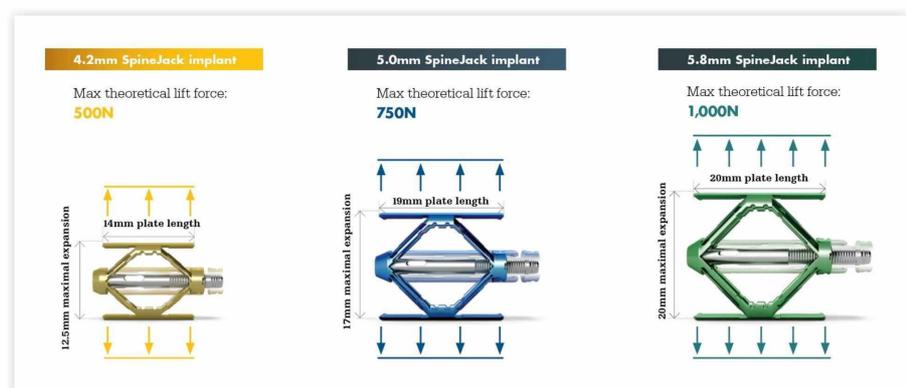
FIGURE 2: Dimensions of the different size SpineJack implants fully opened

The implants come in three sizes: 4.2, 5.0 and 5.8 mm closed. The diameter of the closed implant is critical in determining which size implant can be inserted through the pedicle. When fully deployed and locked in place, they provide different dimensions and Newtons of load support, basically doubling in strength (500-1000 Newtons) from 4.2 to 5.8-mm-sized implants. The opened length of the struts that support the fractured endplate is shown for each implant, which also has different sagittal heights as indicated. (Picture Courtesy: Stryker Corp, Kalamazoo, MI)

The implants come in three different diameters for insertion into the pedicle with sizes of 4.2, 5.0 and 5.8 mm using the internal cortical diameter of the pedicle as the determining factor for size. When fully opened, each device has different heights and lengths, varying from 12.5 x 14.0 mm to 20.0 x 20.0 mm. The lift forces have been calculated and are reflected as compression load strengths described as force in newtons [10,16]. It is important to note the change in lift force with implant size, increasing 50% from 4.2 to 5.0 mm and 100% from 4.2 to 5.8 mm, so it may be important to use the largest size that will be fit through the pedicle. The 4.2-mm implant has been placed in mid and upper thoracic levels (Figure 2) [10].

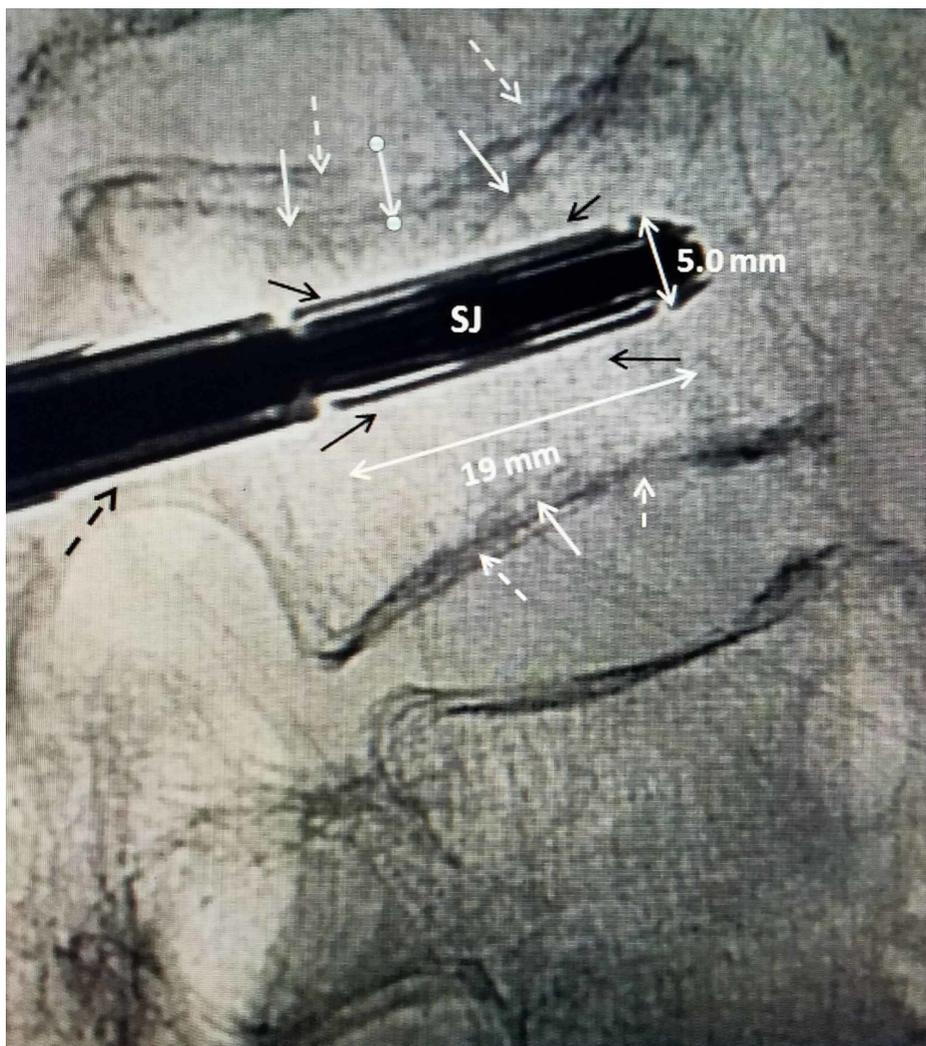
FIGURE 3: A closed 5.0-mm SpineJack implant aligned under superior endplate fracture

The closed implant is centered directly under the compressed superior endplate fracture. The dimension of the closed SJ is marked, 19.0-mm length and 5.0-mm diameter (double-headed white arrows). The 'struts' of the implant are seen in a closed position (solid black arrows) and make part of the diameter of the closed implant. The double shadow of the compressed superior and inferior endplates from each side are seen (solid white arrows and dashed white arrows). The insertion handle of the SJ is seen going through the pedicle (dashed black arrow).

Procedure: Under local anesthesia, similar to VA or BKP, with the patient placed in a prone position, after the fractured level is located, the device is inserted under local anesthesia. The fractured vertebra is localized and often if spinal hyper-extension is performed at this time, the collapsed vertebra can be seen to partially re-expand. This is found more commonly when CT or MRI reveals vacuum clefts within the fracture and is a sign of instability [3-4]. Next, two small 11-gauge vertebroplasty cannulas are used to access both pedicles but only up to the posterior margin of the vertebral body. A firm, 1.5-mm k-wire is then advanced to the anterior one-third of the vertebra on each side and the cannulas are removed. Next, a cannulated-sized reamer is used that matches the implant size selected. The reamer is passed over the k-wire and creates a path of the exact diameter as the closed implant for inserting the closed SJ device. The reamer also allows minor changes to correct angulation if needed. After both sides have been 'reamed', a sizer is used, that is exactly the same size as the closed implant so that the cavity can be properly positioned along the entire length of the fractured endplate. A lucent plastic marker with only a radio-opaque 5-mm tip is left in one side while the parallel opposite side is drilled so the two implants can be precisely aligned under fluoroscopic imaging (Figure 3).

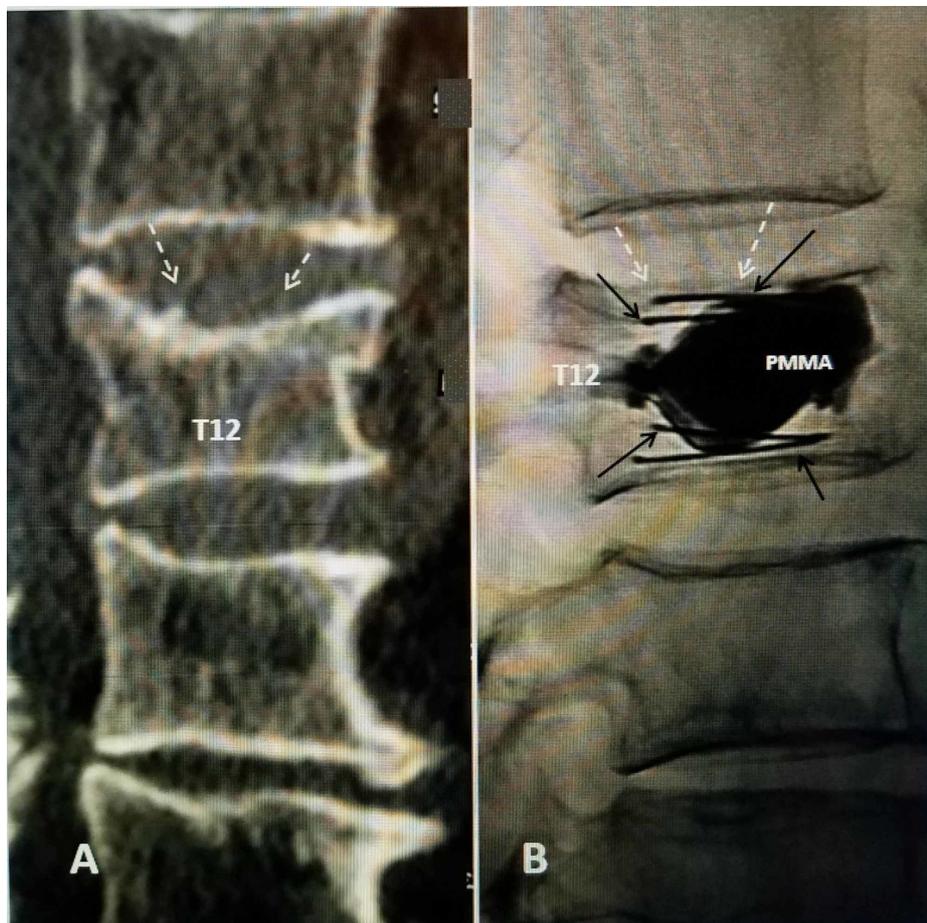
FIGURE 4: T12 fracture with two SpineJack implants placed in vertebral body with re-expansion of the superior endplate

A: Pre-operative sagittal CT scan showing compression fracture of the superior endplate of T12 (dashed white arrows).

B: Post-procedure digital fluoroscopic lateral image showing almost complete re-expansion of the superior endplate (dashed white arrows). The struts of the two parallel SpineJack 5.0-mm implants are clearly seen extending under the length of both superior and inferior endplates (solid black arrows). The cement is confined between the struts and the two implants (PMMA).

The implant is then inserted on both sides and aligned superiorly and inferiorly, and then symmetrically expanded using a specially designed tool which locks into the device and expands the implant by pulling the two ends of the implant towards each other. Each implant is slowly expanded, alternating between implants so the expansion is smooth and symmetric without putting asymmetric stress on the fractured endplates on one side. This compression of the device causes the implant to open in an inferior-superior direction only, due to the machined grooves. A simple mechanism locks the implant into the desired position as controlled by the physician. Once the desired expansion is obtained, the device is left in place inside the restored vertebra and polymethylmethacrylate (PMMA) bone cement is injected (Figure 4).

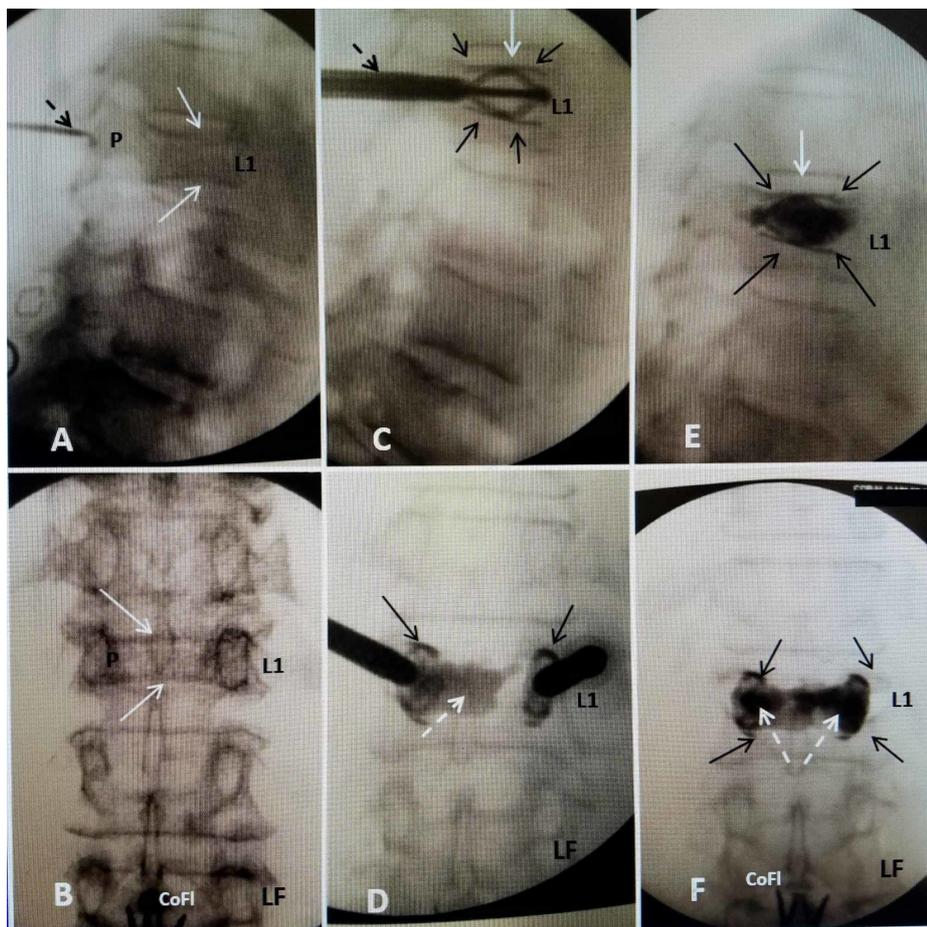
FIGURE 5: L1 acute compression fracture with sequential insertion of bilateral SpineJack implants followed by PMMA cement, demonstrating restoration of vertebral height

A: Lateral intra-operative fluoroscopy showing superior endplate fracture of L1 (solid white arrow). The introducer cannula (dashed black arrow) for the k-wire is placed in line with the pedicle (P).

B: Anterior-posterior (AP) film showing a biconcave collapse of both superior and inferior endplate of L1 (solid white arrows).

C: Lateral fluoroscopy showing the introducer cannula (dashed black arrow). The expanded 5.8-mm SJ is clearly seen before bone cement injected. The two SpineJacks are parallel and the struts pass along the length of the endplates restoring vertebral height especially in the middle of the superior endplate (solid white arrow).

D: Anterior-posterior (AP) intra-operative fluoroscopy showing the PMMA cement being injected unilaterally, on the right side, through the SJ implant (dashed white arrow). The struts are seen above and below the cement is pooling around the device and across the midline (dashed white arrow). The implant on the left (LF) is expanded but has not been injected with cement yet.

E: Lateral film after completed cement injection bilaterally. The superior and inferior struts (solid black arrows) appear to limit spread within and between the two implants. The fractured superior endplate has been restored to normal height (solid white arrow) with the struts supporting the superior endplate back to normal height.

F: AP film after PMMA cement injected in both implants. The superior struts and inferior struts (solid black arrows) are seen bilaterally. Bone cement is filling both devices and completely across the midline (dashed white arrows), compared to what is seen in 'D'.

Regular fluoroscopic controls throughout the operative procedure ensure correct implantation. The PMMA cement is injected through a pipette with a special attachment through the center mechanism of the device so cement exits small ports initially anteriorly and subsequently, the cement then spreads across the midline between the devices and spreads dorsally along and inside the opened implant. This minimizes the possibility of posterior cement spread and the risk of leakage of cement into the spinal canal. The general surgical time to perform bilateral insertion of SJ implants with PMMA cement is similar to bilateral balloon kyphoplasty. The resultant vertebra not only has height restoration but broad anterior and lateral support by the devices with cement intermingled in the titanium struts and across the midline (Figure 5).

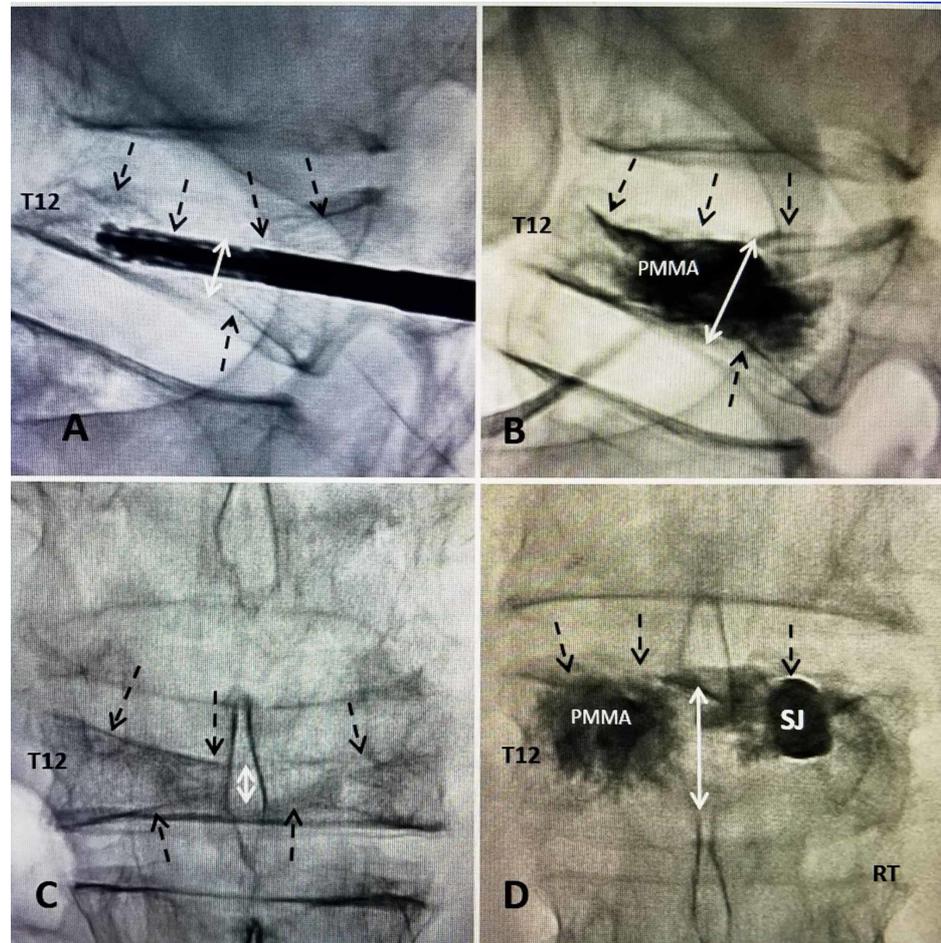
FIGURE 6: T12 acute compression fracture treated with 4.2-mm SpineJack

A: Initial lateral intra-operative film showing a 70% middle (double-headed white arrow) and anterior compression fracture of T12. The closed 4.2-mm SJ and attached handle are seen centered under the fracture. The bi-concave superior endplate fracture (four dashed black arrows) and lesser and more posterior inferior endplate fracture is seen (single dashed black arrow).

B: Lateral film after expansion of SJ in the center of T12 raising the middle part of the superior endplate fracture (three dashed black arrows). The 4.2-mm implant expands to 14.0 x 17.0 mm. It is filled with cement (PMMA). The middle T12 height has expanded three-fold (double-headed white arrow) and the inferior posterior endplate is also slightly expanded (single dashed black arrow). Note that the cement (PMMA) remains localized around the implant and none is tracking posteriorly toward the spinal canal.

C: Anterior-posterior (AP) film before insertion of SJ showing marked collapse in the center of T12 (double-headed white arrow). The central vertebral collapse is mostly from depression of the center superior endplate (3 dashed black arrows) compared to the inferior endplate (two dashed black arrows). Normally the posterior and lateral walls remain closer to normal height with high degree collapse because of the stronger superior and medial pedicle cortex that maintains the posterior vertebral wall.

D: AP fluoroscopy film after both SJ implants was inserted. Cement (PMMA) was injected in the left, before the right and is crossing the midline. The superior endplate is significantly elevated from the pre-implant film in 'C' and the midline height is restored (double-headed white arrow) especially in the center of T12 (three dashed black arrows). The right SJ has not been injected with cement.

Biomechanical studies found that a more trabecular spread of cement distributes the load and stiffness throughout a wider area of the fractured vertebra [2,7]. This may be one of the reasons for less adjacent fractures with simple VA in distinction to BKP, where the cement is used in larger volumes and is placed in a more globular concentration [6,9,11]. Cement in the region of the endplate nearest the adjacent fractured vertebra is also critical to reducing the incidence of continued collapse. In a study of technical reasons for the recurrence of a fracture within the same vertebra, it was found that one of the main reasons for the continued collapse of a previously treated vertebra and the adjacent vertebra was non-filling or insufficient cement placement around the fractured area and a lack of cement specifically filling near the fractured endplate [7,11]. The SpineJack^R implant creates a symmetric broader load support directly under the osteoporotic collapsing superior cortex and endplate based on precise placement of bilateral 'struts' which are supplemented by PMMA cement. The force generated by the bilateral implants varies by implant size but ranges from 500 to 1000 Newtons of load support under the fractured endplate, as well as load from the spinal column. (A Newton is equivalent to 4.48 pounds (lbs) and so 500 Newtons is 112 pounds per implant for the 4.2 mm SJ to 1000 Newtons for the 5.8 mm SJ or 224 lbs per implant). The PMMA cement is incorporated within the cancellous bone inside, around and especially between the two implants, both laterally and anteriorly creating a broad supporting ring under the endplate. The mechanical center of each 'strut' is under the fracture, the extended wings spread the load and provide a broad large force strength along the length of the fracture, similar to skis 'floating' above the snow, as the skier is centered on long extended skis [17-18]. These implants are effective with high degrees of vertebral collapse and angulation which is more common at the thoracolumbar junction (Figure 6).
