# Radiolucent Skull Clamps for Intra-Operative Imaging: A Technical Note

**Categories:** Radiology, Neurosurgery, Healthcare Technology

**Keywords:** intraoperative imaging, skull clamp, radiolucent, metal artifact, cone beam ct

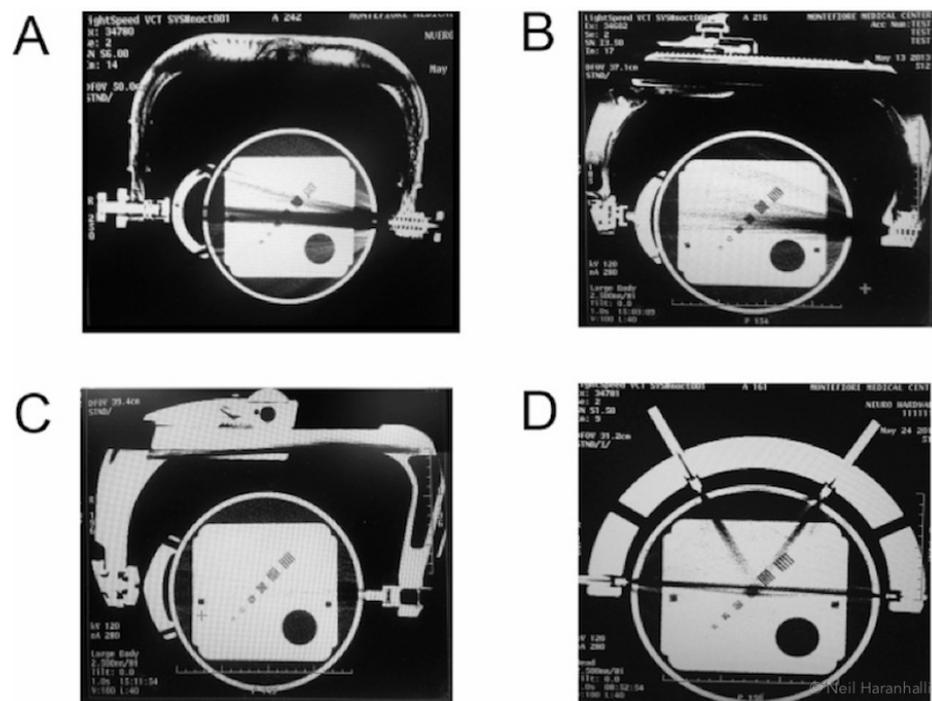
**FIGURE 1: Four near-radiolucent frames in conventional CT**

Figure.1 depicts the results of four near-radiolucent skull clamps. Both of the Mayfield clamps and the Doro clamp, although to a lesser extent, (Fig. 1A-C) suffer from metal artifacts due to a spring in the one pinned arm. The Sugita frame (Fig. 1D) has no spring, but pins connected to the rest of the head frame are not radiolucent and show artifacts along the lines from the pins. As observed in Fig. 1, the artifacts are dominated by dark lines (originating from beam hardening and scatter as discussed above). The intensity of the X-ray was set to 120 kV.

Upper row (A and B), two Mayfield skull clamps (C). A radiolucent Doro skull clamp (D). A Sugita carbon fiber head frame. Note the dark streaks along the line of greatest attenuation originating from the metal objects adjacent to the pins

Here, we addressed a specific problem with current skull clamps and pins, i.e. they are not fully radiolucent. We observed that the major source of artifacts is the spring in the one pinned arm. The spring serves to provide a margin of error to the pressure delivered to the skull by tightening of the screw. The most obvious solution would be to remove the spring and replace this protective feature with another protective

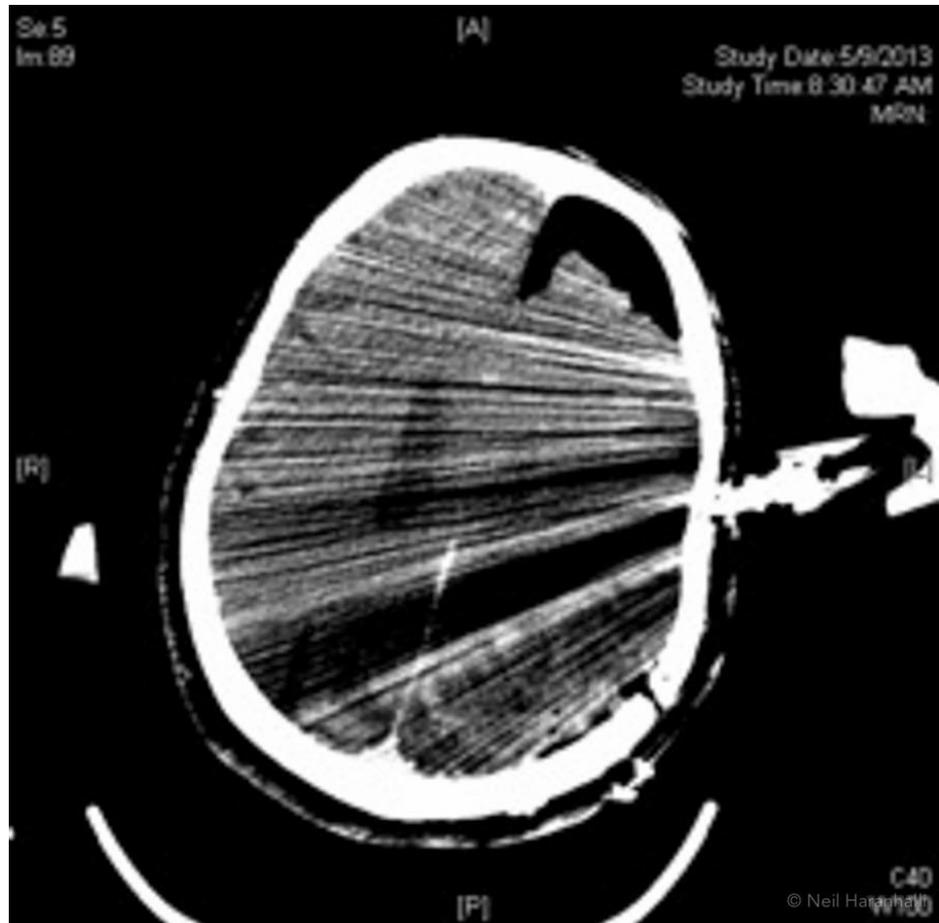
**FIGURE 2: Intraoperative image demonstrating metal streak artifact**

During surgery, a radiolucent Doro skull clamp was used (such as used in Figure 1 C) and a BodyTom scanner was done to assess the completeness of neoplasm removal. However, artifacts originating from the skull clamp used made such an evaluation impossible. As can be inferred from Fig. 2, which is similar to Fig. 1, there is a dark streak that comes from the spring on the one pinned arm. Moreover, the entire field of view is obscured by alternating black and white lines which are an expected difference [6, 8-11] when cone beam CT is used compared with conventional CT (Fig. 1). Another possible explanation could be patient motion, which is known to cause this type of artifact [2]. For the images rendered with conventional CT using a phantom, neither problems involving cone beam X-ray nor patient motion were present. Regardless of the cause, the image quality degradation was so severe that the medical utility was highly diminished.

Note the dark streak in the line of the right pin and the adjacent white streaks. Compared with Fig.1, virtually the entire field of view is obscured. The dark streaks are more prominent compared with Fig.1 due to the lateral parietal bone enhancing the metal streak artifact
